2005 Cadillac XLR Windshield Replacement in Phoenix, AZ

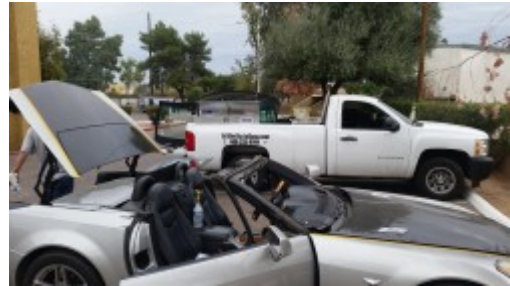
To the left you can clearly see that this customer may have had some severe wind noise in the passenger corner. How this is even possible I'm not quite sure, unless they ran their glue directly onto the windshield, then set the windshield in.

The image to the right probably allowed a high pitched whistle, since there is empty space underneath where the two points meet. In either case, running your bead directly on top of the existing factory bead after it is trimmed out is the way to go, with as few seams as possible, checking to make sure there are no holes in your seams, and as straight as possible.
